Technical Report ARWSB-TR-11011

Evaluation of Flash Bainite in 4130 Steel

JULY 2011

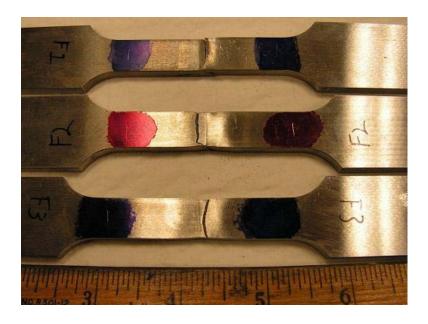
Welding with 4130 wire followed by FB post-weld heat treatment produces the same yield strength as unwelded FB; however, at least half of the ductility is lost in the welded area. A welding engineer observed lack of penetration, which might have contributed to loss of ductility. That is, there appears to be a lack of penetration at weld root. These post-weld heat treated tensile specimens failed at or near the interface of weld metal / base metal (Figure 14).

Figure 14. Post-weld FB tensile specimens failed at/near the interface of weld metal / base metal.
